# Photographs for Mid-City Plating IND 006 049 456

## Media: RCRA

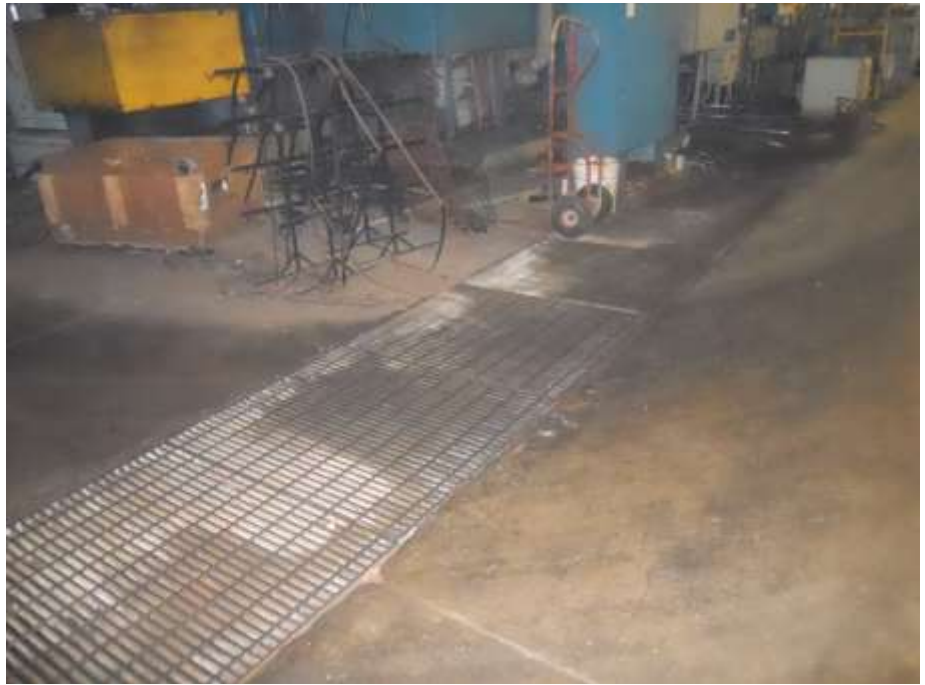
**Disk Number** 1  
**Photo Number** 1  
**Photo Filename** DSCN0586.JPG  
**Date/Time** 9/11/2013  
10:10:00 AM  
**Photographer** Jamie Paulin

Hanson Line. Not in-use at the time of the inspection. However, there was still sludge/liquid within the waste water treatment trench/line.

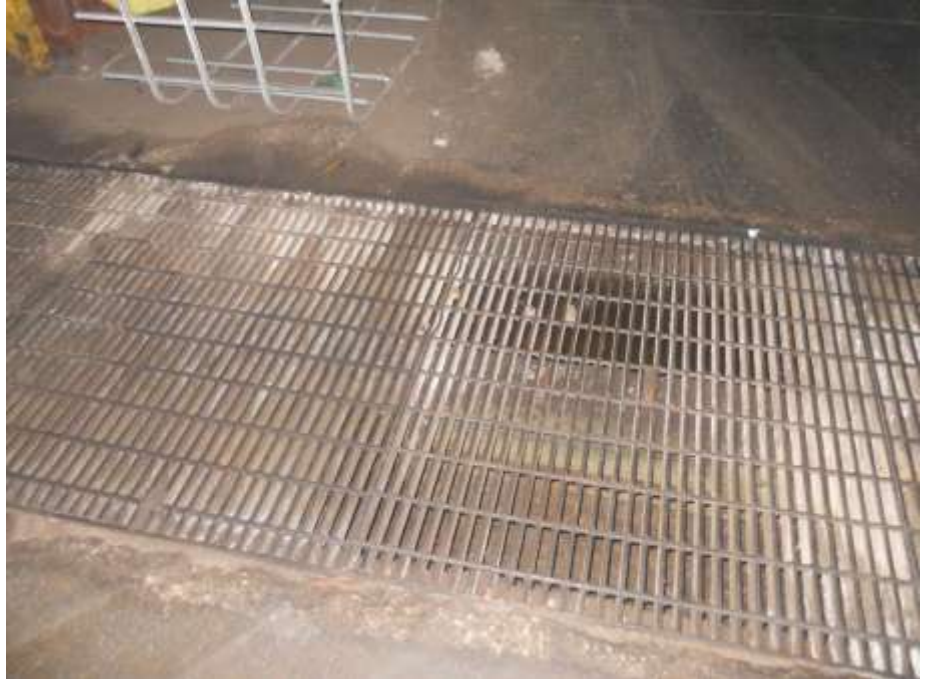
**Disk Number** 1  
**Photo Number** 2  
**Photo Filename** DSCN0587.JPG  
**Date/Time** 9/11/2013  
10:10:00 AM  
**Photographer** Jamie Paulin

Hanson Line. Not in-use at the time of the inspection. However, there was still sludge/liquid within the waste water treatment trench/line.

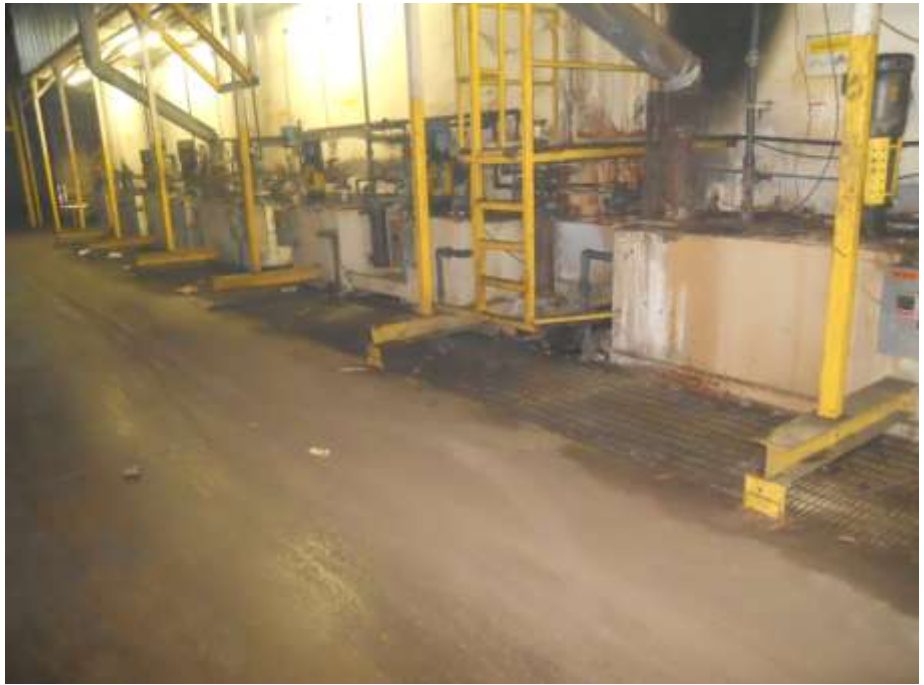
**Disk Number** 1  
**Photo Number** 3  
**Photo Filename** DSCN0588.JPG  
**Date/Time** 9/11/2013  
10:11:00 AM  
**Photographer** Jamie Paulin

E-Coat Line. Liquid was still located in waste water treatment trench. Mid-City Plating thought that the liquid would be non-hazardous based on the type of material used in the E-Coat Process.

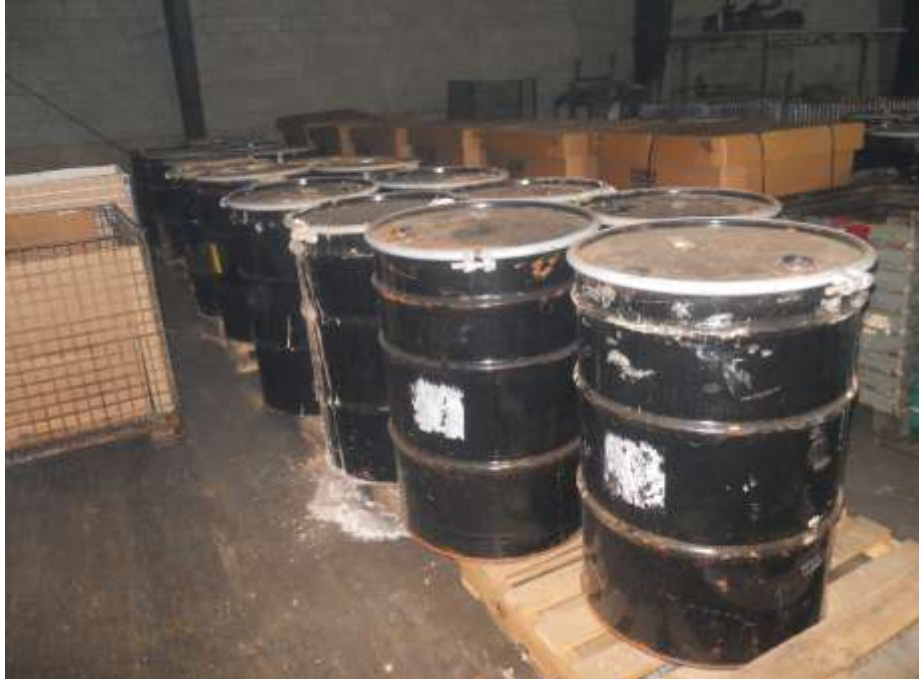
**Disk Number** 1  
**Photo Number** 4  
**Photo Filename** DSCN0589.JPG  
**Date/Time** 9/11/2013  
10:19:00 AM  
**Photographer** Jamie Paulin

Hazardous waste storage area. 26 x 55-gallon containers were being stored on pallets. F008 waste. Haz waste labels were not on 4 containers. 4 containers had dates of accumulation over 90 days, 4/16/13, 4/17/13, 4/23/13, & 5/21/13.

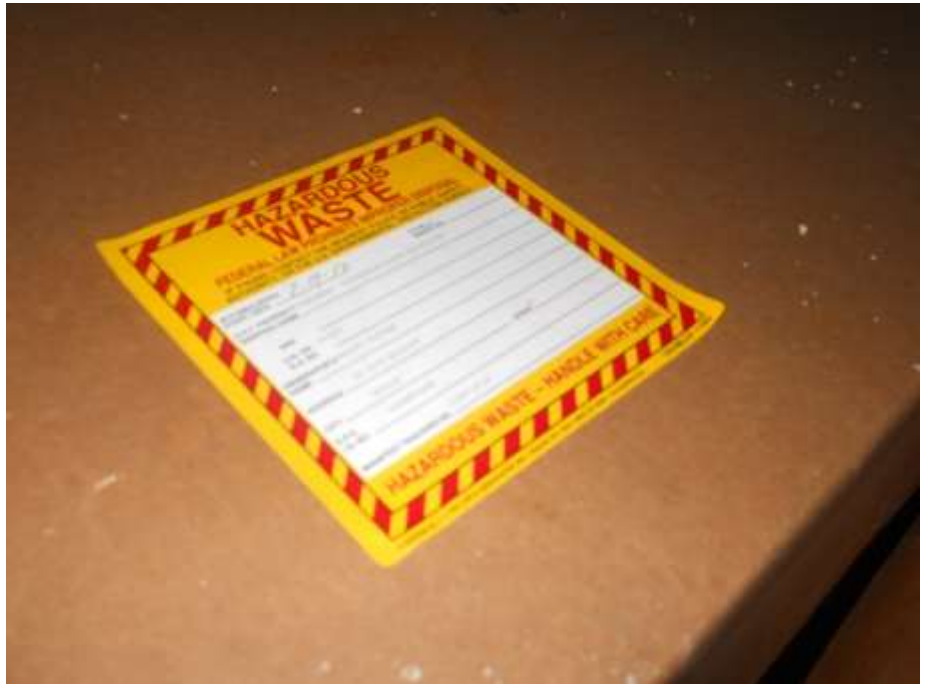
**Disk Number** 1  
**Photo Number** 5  
**Photo Filename** DSCN0590.JPG  
**Date/Time** 9/11/2013  
10:25:00 AM  
**Photographer** Jamie Paulin

Waste water treatment sludge storage - F006. Hazardous waste labels were not on 4 out of 6 cubic yard boxes. Dates of accumulation were over 90 days for three boxes, 7/19/12, 3/13/13, and 5/23/13.

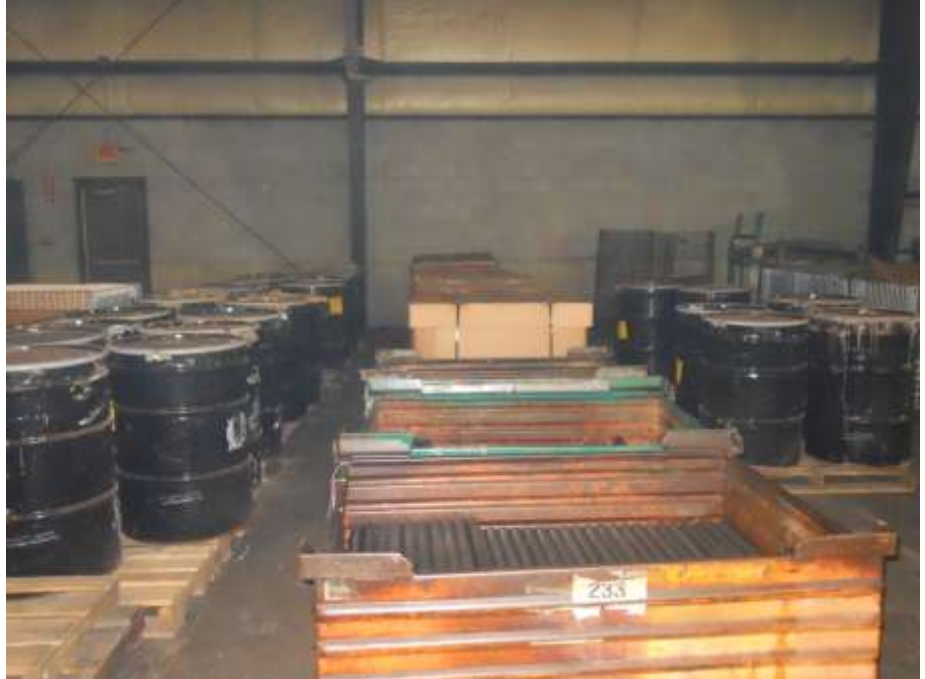
**Disk Number** 1  
**Photo Number** 6  
**Photo Filename** DSCN0591.JPG  
**Date/Time** 9/11/2013  
10:25:00 AM  
**Photographer** Jamie Paulin

Over view of hazardous waste storage area. 55-gallon container and cubic yard box storage.

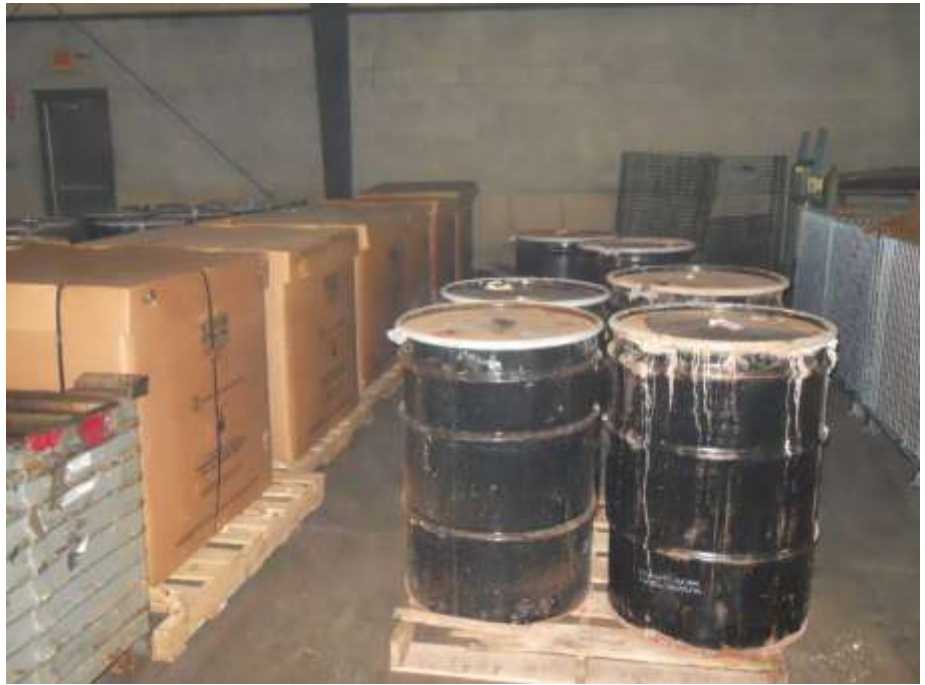
**Disk Number** 1  
**Photo Number** 7  
**Photo Filename** DSCN0592.JPG  
**Date/Time** 9/11/2013  
10:26:00 AM  
**Photographer** Jamie Paulin

Over view of hazardous waste storage area. 55-gallon container and cubic yard box storage.

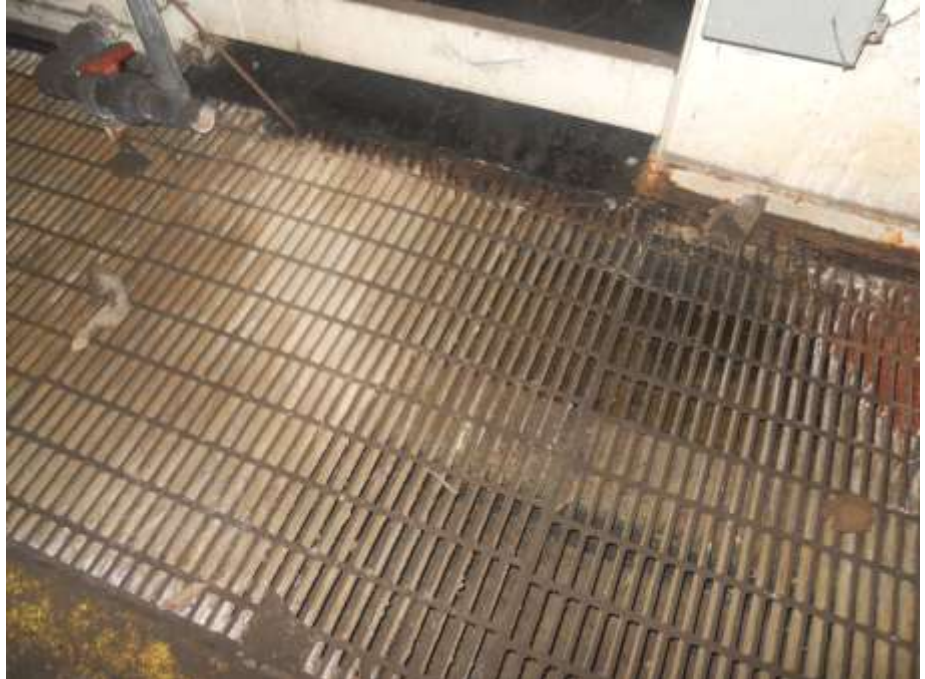
**Disk Number** 1  
**Photo Number** 8  
**Photo Filename** DSCN0593.JPG  
**Date/Time** 9/11/2013  
10:27:00 AM  
**Photographer** Jamie Paulin

Liquid still located in the E-Coat Line waste water treatment trench. Mid-City Plating thought the liquid could be non-hazardous based on E-Coat Process.

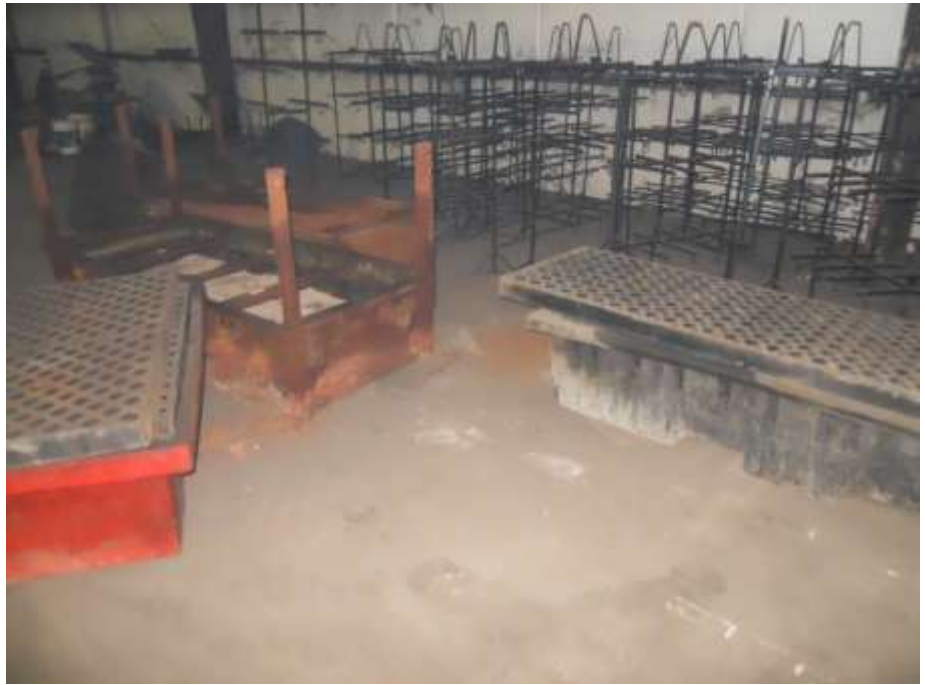
**Disk Number** 1  
**Photo Number** 9  
**Photo Filename** DSCN0594.JPG  
**Date/Time** 9/11/2013  
10:28:00 AM  
**Photographer** Jamie Paulin

Central Location of Facility. Container trench had been cleaned and emptied. The material had been added to the F006 hazardous waste storage.

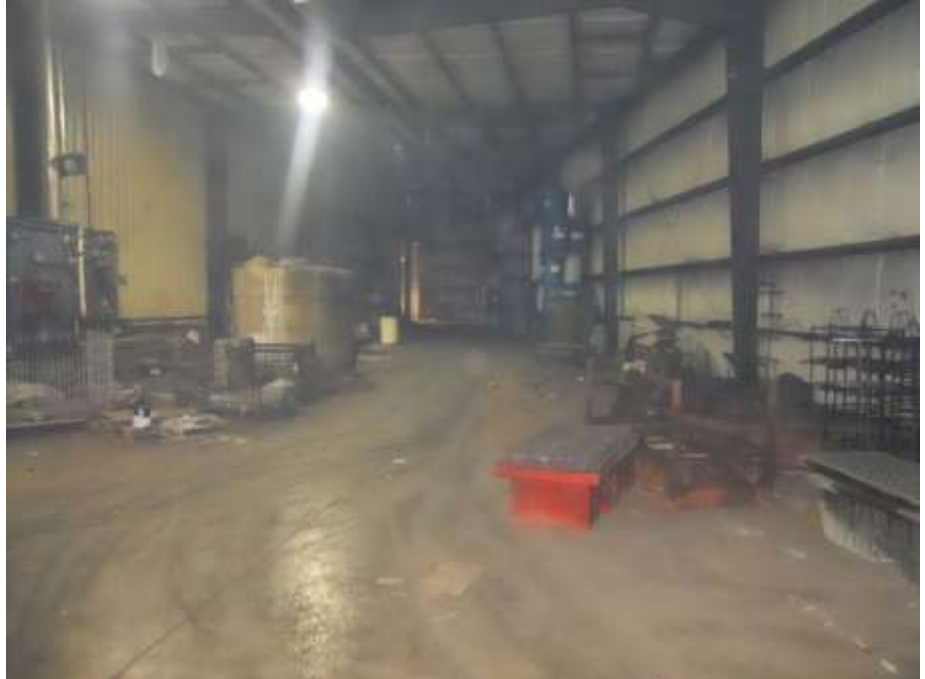
**Disk Number** 1  
**Photo Number** 10  
**Photo Filename** DSCN0595.JPG  
**Date/Time** 9/11/2013  
10:29:00 AM  
**Photographer** Jamie Paulin

Overview of central location, where empty containers, equipment and product are stored. Container trench had been cleaned and emptied. The material had been added to the F006 hazardous waste storage.

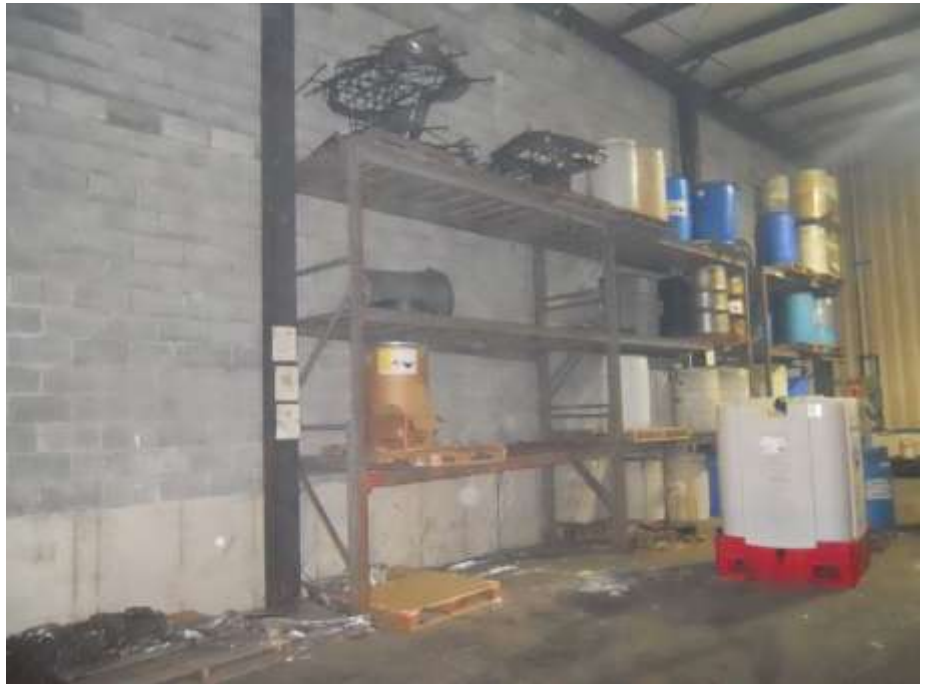
**Disk Number** 1  
**Photo Number** 11  
**Photo Filename** DSCN0596.JPG  
**Date/Time** 9/11/2013  
10:30:00 AM  
**Photographer** Jamie Paulin

Storage and Shelving area, located in central area of facility. Some empty containers and products were being stored on the shelving unit.

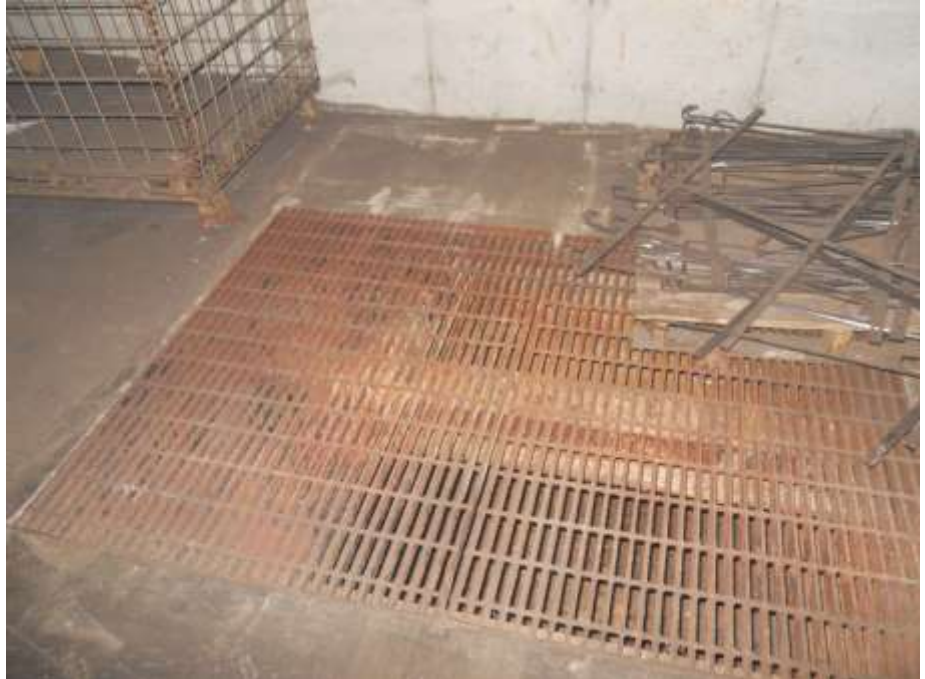
**Disk Number** 1  
**Photo Number** 12  
**Photo Filename** DSCN0597.JPG  
**Date/Time** 9/11/2013  
10:32:00 AM  
**Photographer** Jamie Paulin

Storage room, located in central area of facility. Trench had been cleaned and emptied. Material was categorized as F006 hazardous waste and shipped off-site for disposal.

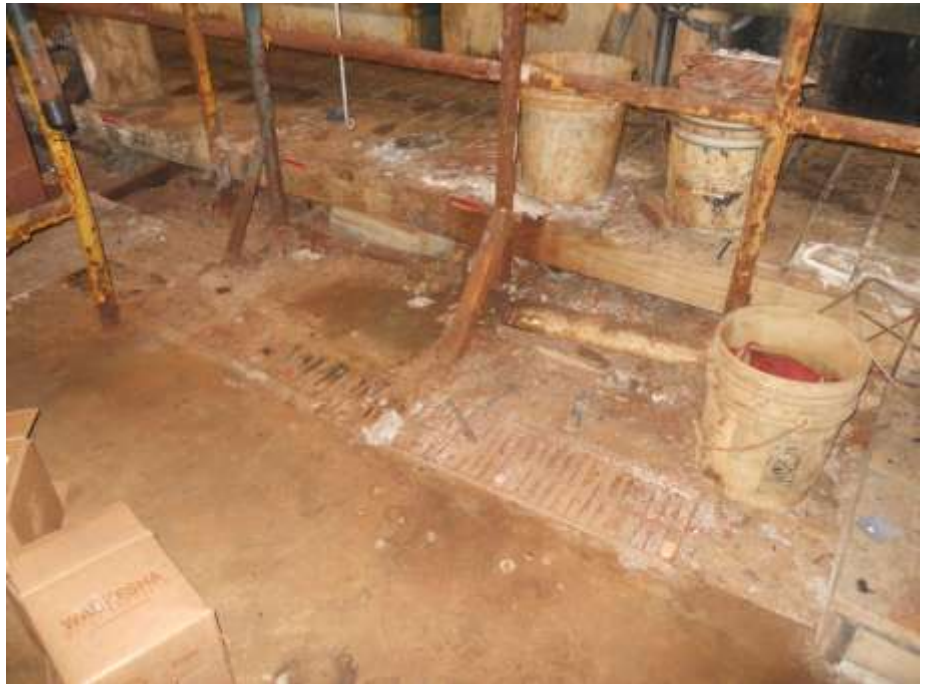
**Disk Number** 1  
**Photo Number** 13  
**Photo Filename** DSCN0598.JPG  
**Date/Time** 9/11/2013  
10:33:00 AM  
**Photographer** Jamie Paulin

Barrel Line location. Debris and material were still located near and underneath the line.

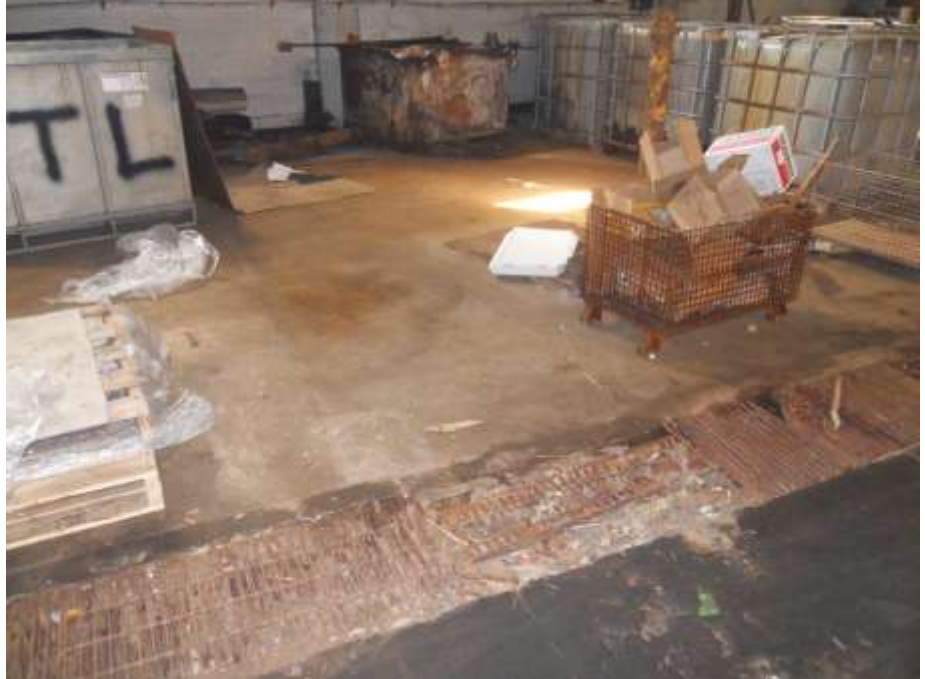
**Disk Number** 1  
**Photo Number** 14  
**Photo Filename** DSCN0599.JPG  
**Date/Time** 9/11/2013  
10:33:00 AM  
**Photographer** Jamie Paulin

Central location, near the Barrel Line. Debris and material were still located within the waste water treatment trench. The totes were used to transport material to the waste water treatment system.

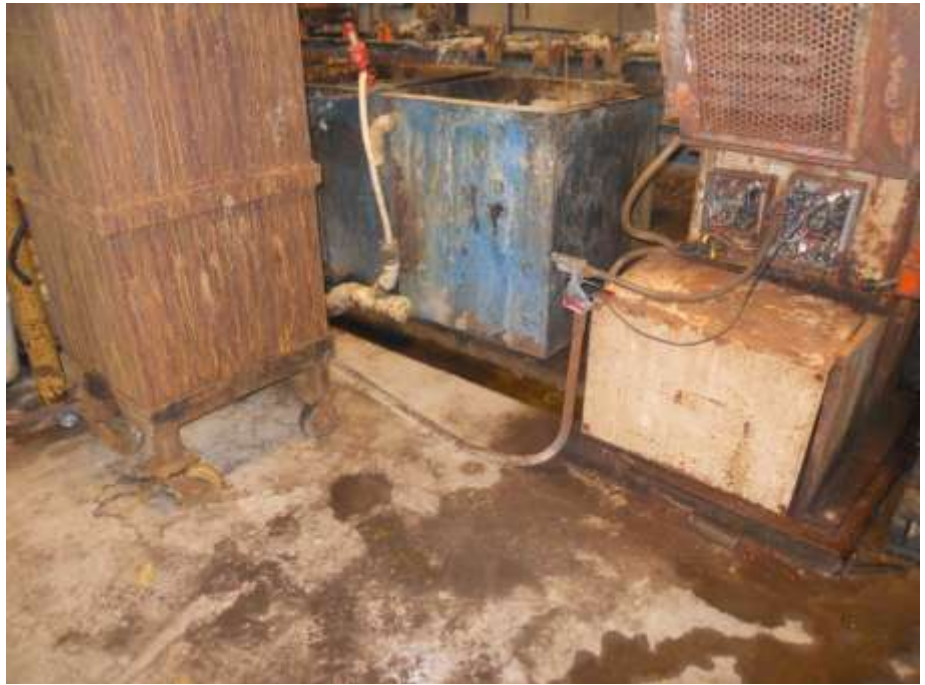
**Disk Number** 1  
**Photo Number** 15  
**Photo Filename** DSCN0600.JPG  
**Date/Time** 9/11/2013  
10:34:00 AM  
**Photographer** Jamie Paulin

Barrel Line. Liquid was located within the containment area underneath the plating line.

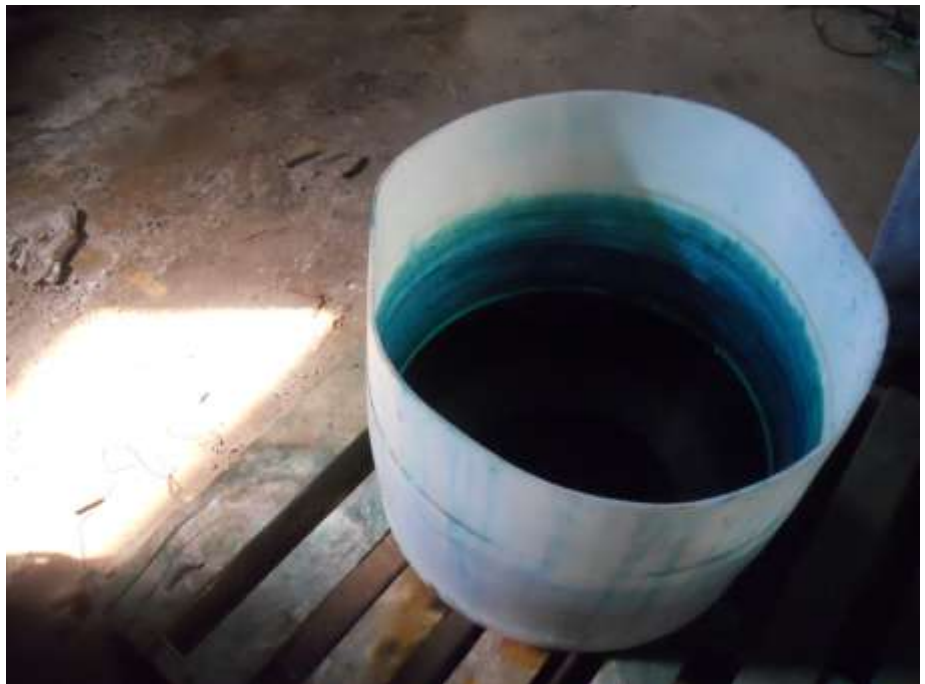
**Disk Number** 1  
**Photo Number** 16  
**Photo Filename** DSCN0601.JPG  
**Date/Time** 9/11/2013  
10:34:00 AM  
**Photographer** Jamie Paulin

Open barrel of rit dye. Parts are dipped into the barrel for parts staining.

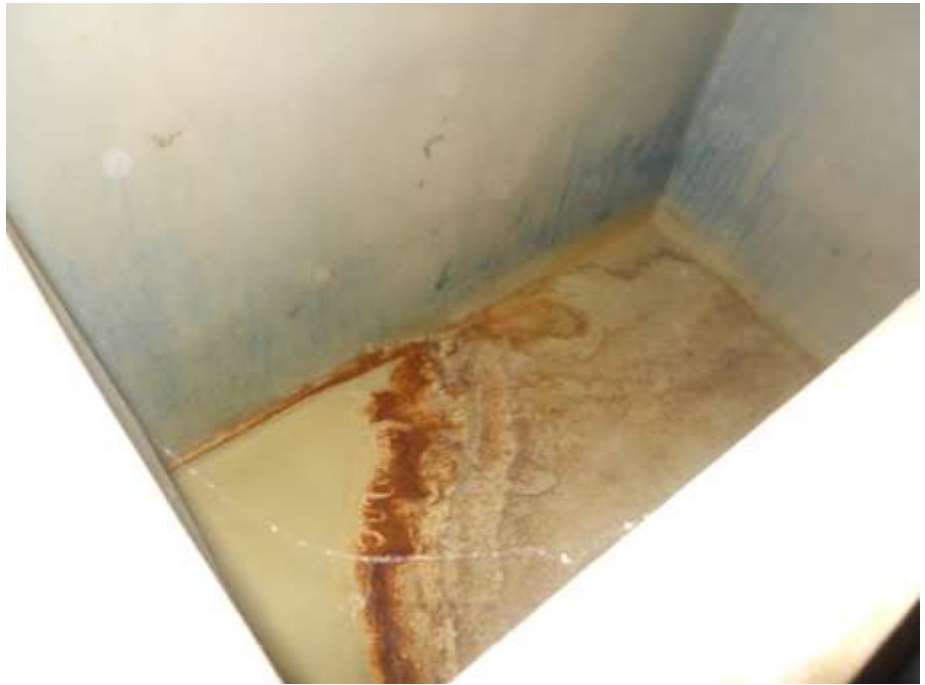
**Disk Number** 1  
**Photo Number** 17  
**Photo Filename** DSCN0602.JPG  
**Date/Time** 9/11/2013  
10:35:00 AM  
**Photographer** Jamie Paulin

Passivation bath. Mostly empty; however a light film of liquid was located at the bottom of the tub.

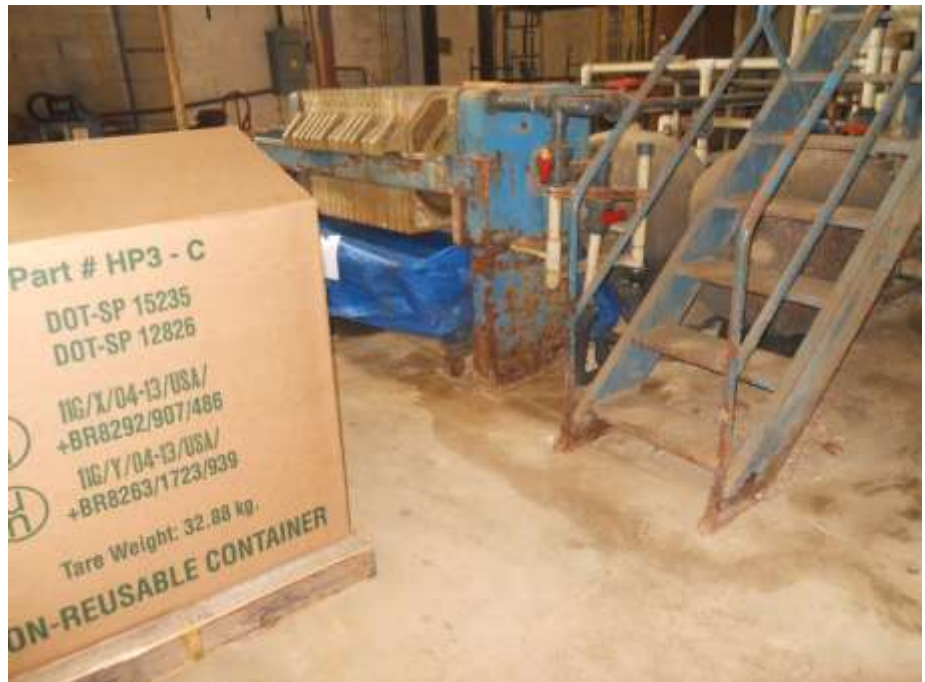
**Disk Number** 1  
**Photo Number** 18  
**Photo Filename** DSCN0603.JPG  
**Date/Time** 9/11/2013  
10:39:00 AM  
**Photographer** Jamie Paulin

Filter Press Box. Collection of the F006 hazardous waste off of the press. The material is then put into the cardboard box for storage. The box was not labeled as "Hazardous Waste," and did not have an accumulation start date.

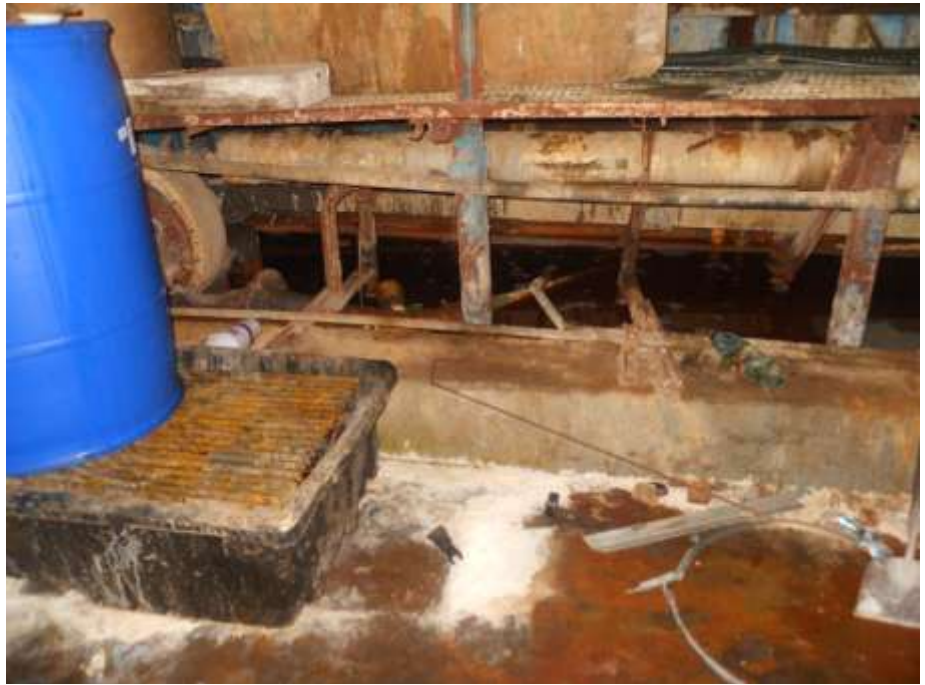
**Disk Number** 1  
**Photo Number** 19  
**Photo Filename** DSCN0604.JPG  
**Date/Time** 9/11/2013  
10:40:00 AM  
**Photographer** Jamie Paulin

Jessup Plating Line. Material was still located in containment below the plating line, which uses cyanide in the process. Mid-City stated that a hose is used to pump the material back into a process bath; however the containment was still full of liquid.

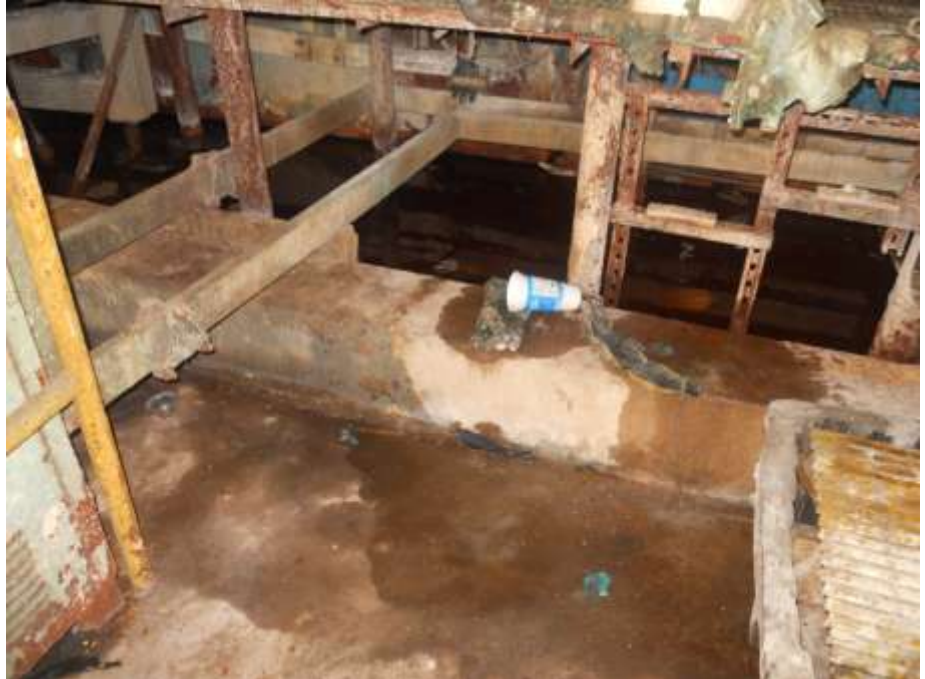
**Disk Number** 1  
**Photo Number** 20  
**Photo Filename** DSCN0605.JPG  
**Date/Time** 9/11/2013  
10:42:00 AM  
**Photographer** Jamie Paulin

Jessup Plating Line. Material was still located in containment below the plating line, which uses cyanide in the process. Mid-City stated that a hose is used to pump the material back into a process bath; however the containment was still full of liquid.

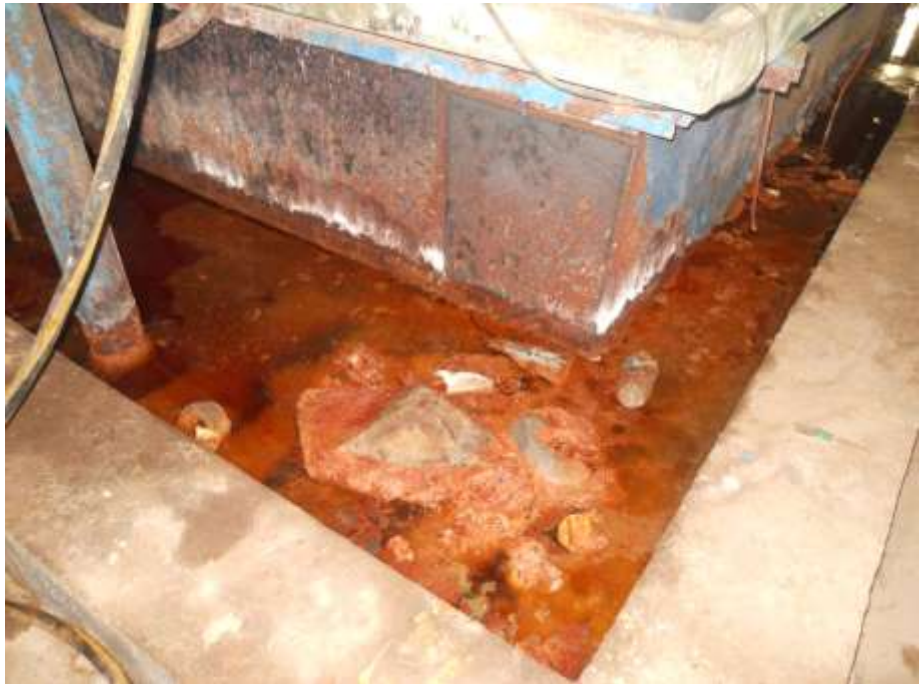
**Disk Number** 1  
**Photo Number** 21  
**Photo Filename** DSCN0606.JPG  
**Date/Time** 9/11/2013  
10:43:00 AM  
**Photographer** Jamie Paulin

Jessup Plating Line. Material was still located in containment below the plating line, which uses cyanide in the process. Mid-City stated that a hose is used to pump the material back into a process bath; however the containment was still full of liquid.

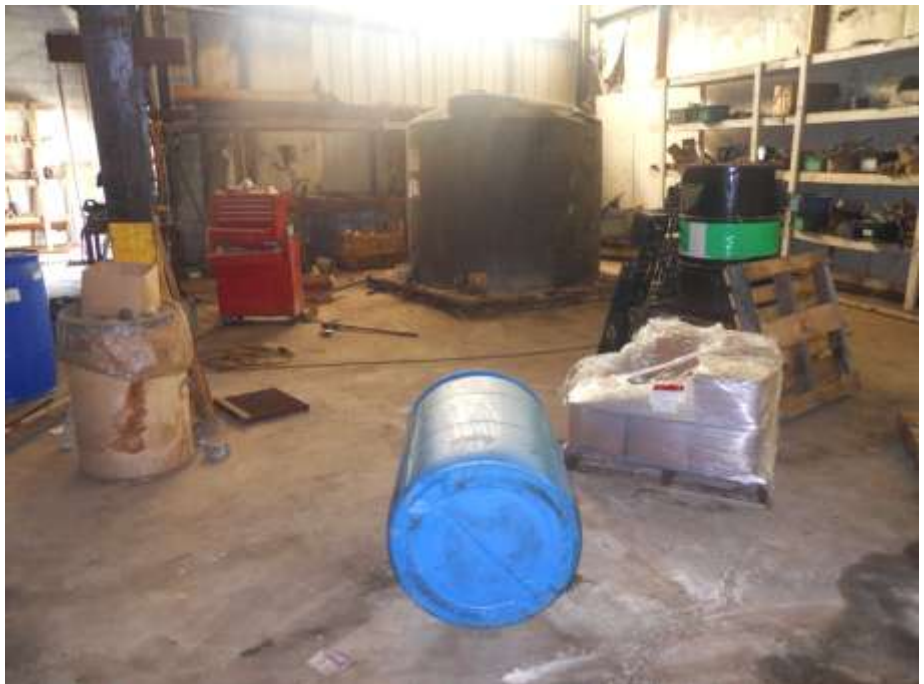
**Disk Number** 1  
**Photo Number** 22  
**Photo Filename** DSCN0607.JPG  
**Date/Time** 9/11/2013  
10:46:00 AM  
**Photographer** Jamie Paulin

Overview of Jessup Plating Line location. Puddles of liquid were no longer located on the floor.

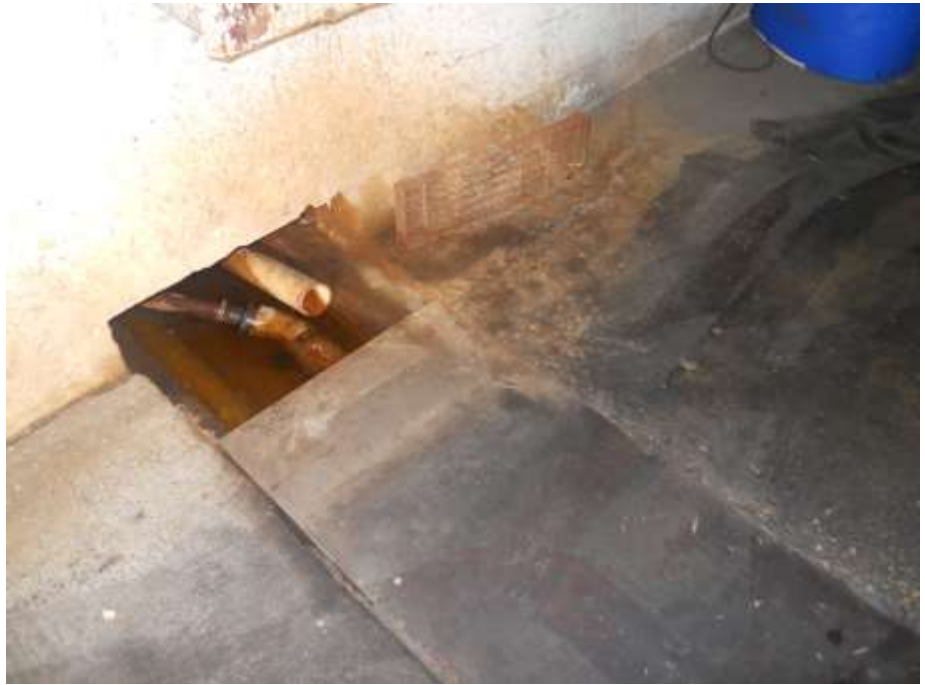
**Disk Number** 1  
**Photo Number** 23  
**Photo Filename** DSCN0608.JPG  
**Date/Time** 9/11/2013  
10:47:00 AM  
**Photographer** Jamie Paulin

Liquid was still located in the waste water treatment (WWT) trench leading from the Jessup Line to the WWT unit.

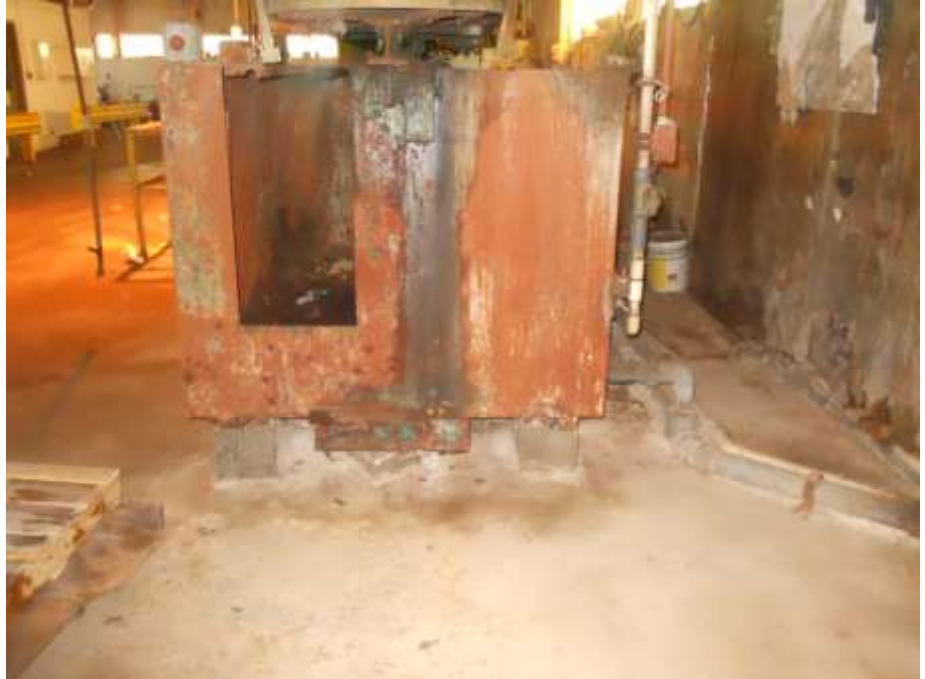
**Disk Number** 1  
**Photo Number** 24  
**Photo Filename** DSCN0609.JPG  
**Date/Time** 9/11/2013  
10:48:00 AM  
**Photographer** Jamie Paulin

Utilite machine. This machine was not in-use at the time of the inspection and is being cleaned for re-commissioning. Kitty litter and material spill had been cleaned off of the floor, outside of machine.

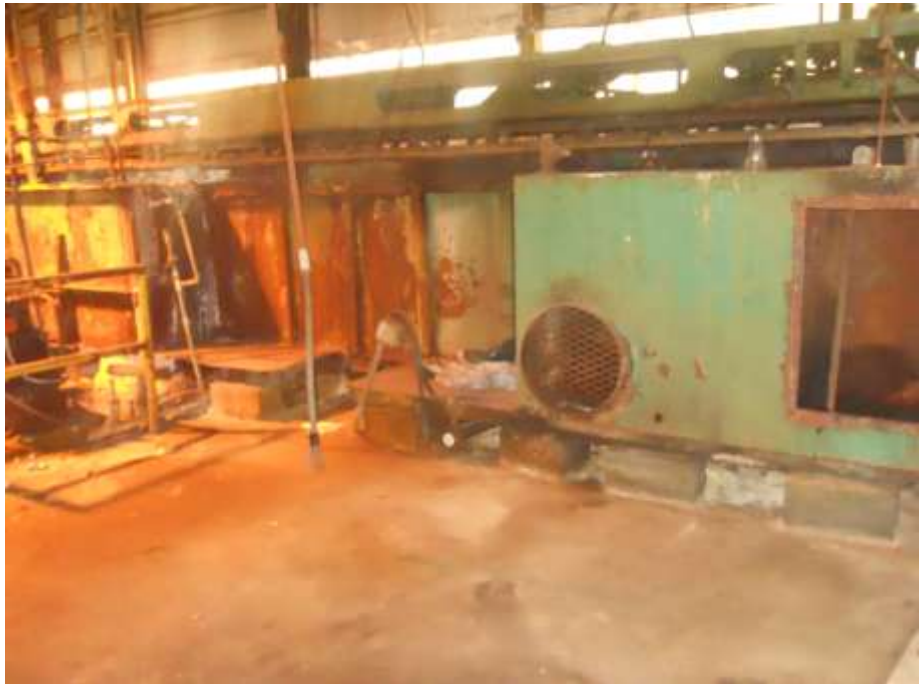
**Disk Number** 1  
**Photo Number** 25  
**Photo Filename** DSCN0610.JPG  
**Date/Time** 9/11/2013  
10:48:00 AM  
**Photographer** Jamie Paulin

Utilite machine. This machine was not in-use at the time of the inspection and is being cleaned for re-commissioning. Kitty litter and material spill had been cleaned off of the floor, outside of machine.

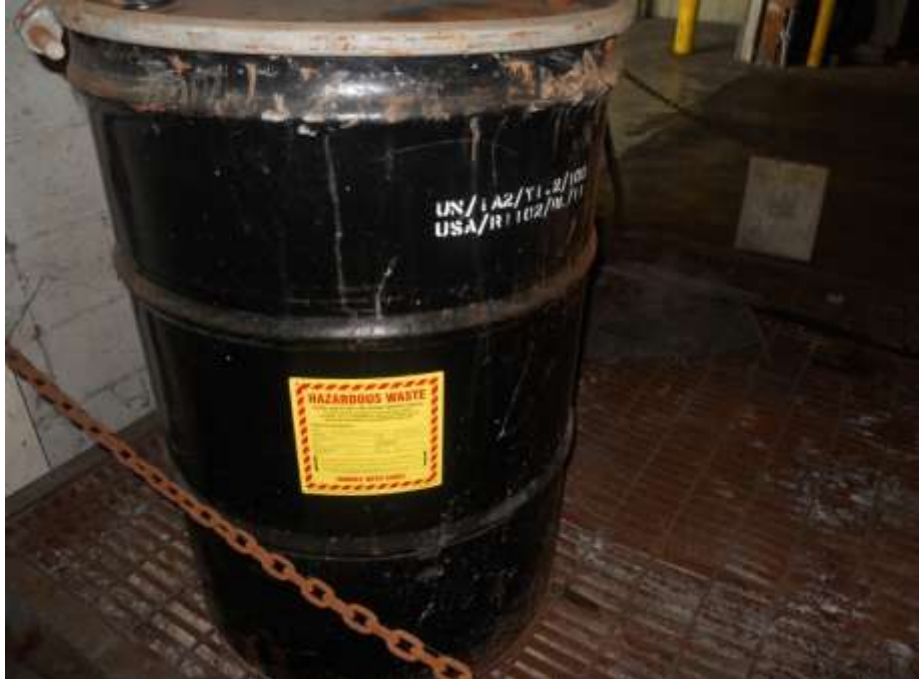
**Disk Number** 1  
**Photo Number** 26  
**Photo Filename** DSCN0611.JPG  
**Date/Time** 9/11/2013  
10:51:00 AM  
**Photographer** Jamie Paulin

One 55-gallon container of F008 hazardous waste was being stored in another hazardous waste storage area. The accumulation start date on the container was 7/13/12, which is over the 90 day storage limit.

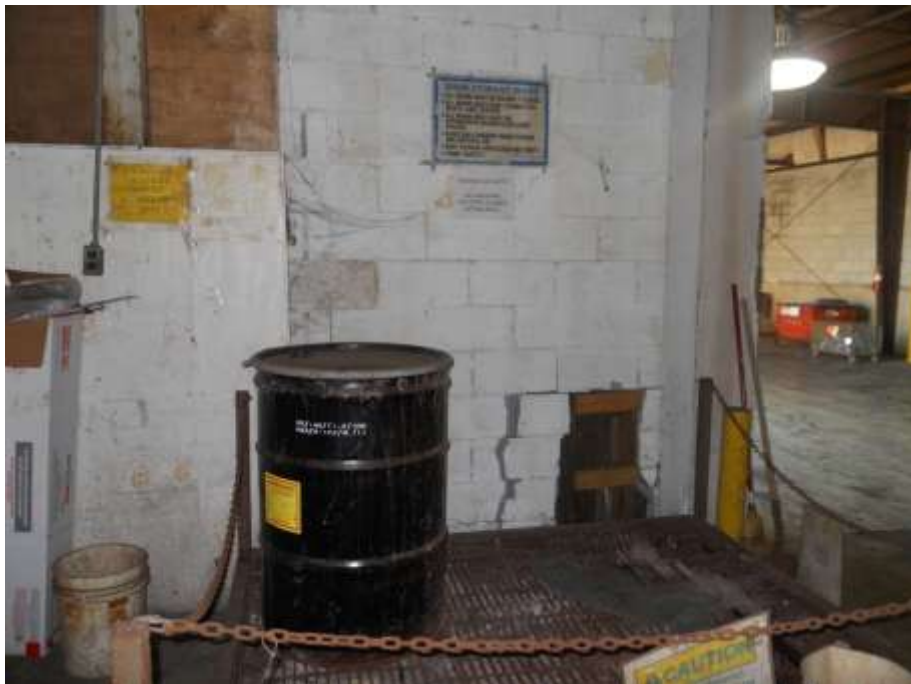
**Disk Number** 1  
**Photo Number** 27  
**Photo Filename** DSCN0612.JPG  
**Date/Time** 9/11/2013  
10:51:00 AM  
**Photographer** Jamie Paulin

One 55-gallon container of F008 hazardous waste was being stored in another hazardous waste storage area. The accumulation start date on the container was 7/13/12, which is over the 90 day storage limit.

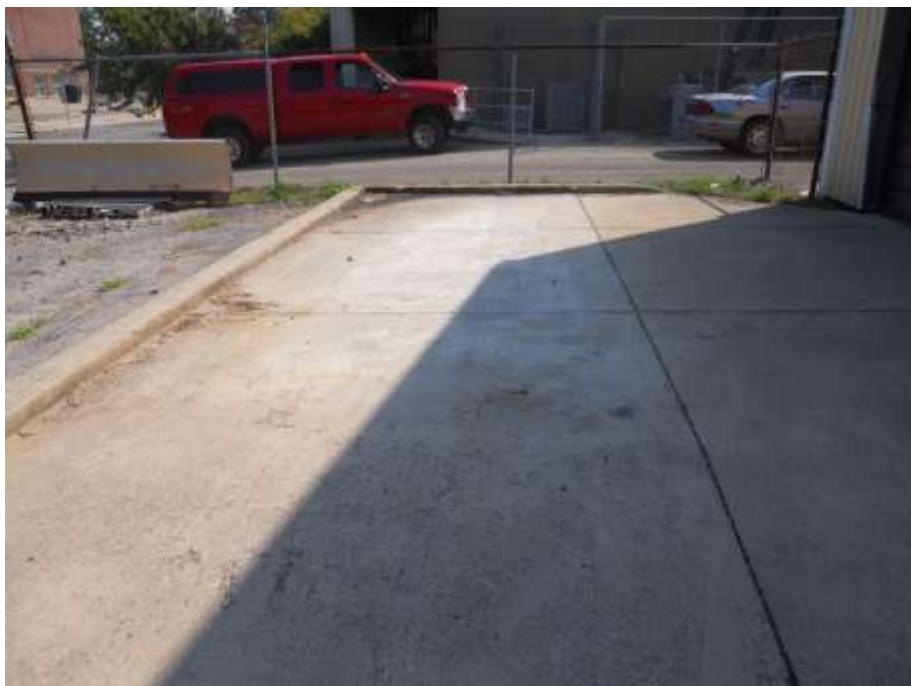
**Disk Number** 1  
**Photo Number** 28  
**Photo Filename** DSCN0613.JPG  
**Date/Time** 9/11/2013  
10:52:00 AM  
**Photographer** Jamie Paulin

Former F006 hazardous waste 20 cubic yard roll-off storage. The roll-off was no longer being stored in this area. No hazardous waste was being stored in this area at the time of the inspection.

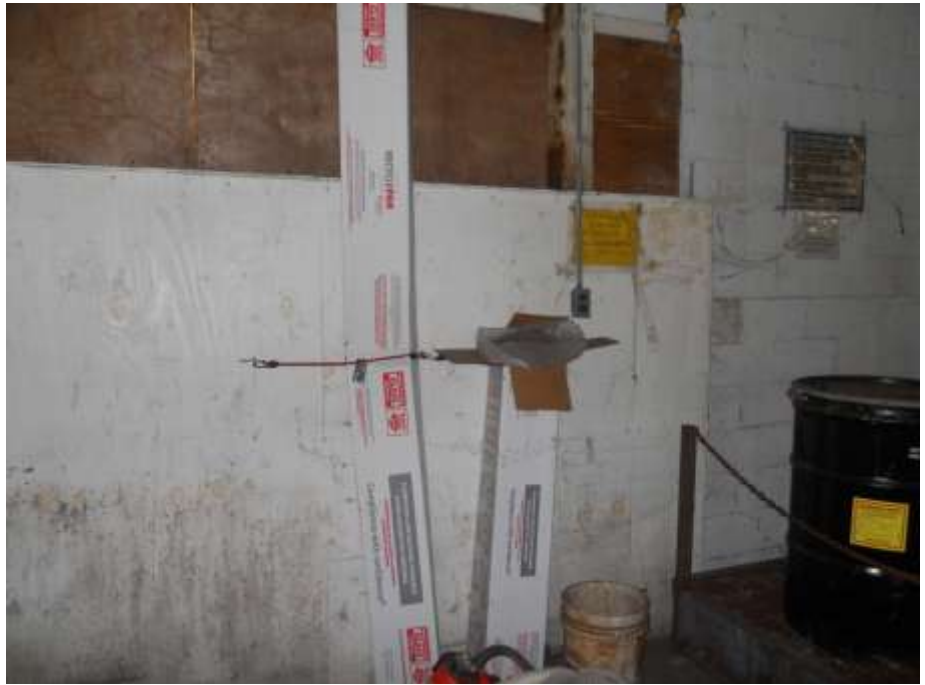
**Disk Number** 1  
**Photo Number** 29  
**Photo Filename** DSCN0614.JPG  
**Date/Time** 9/11/2013  
10:53:00 AM  
**Photographer** Jamie Paulin

Universal Waste Storage. The fluorescent light bulb storage containers were not properly labeled and one container was not closed.

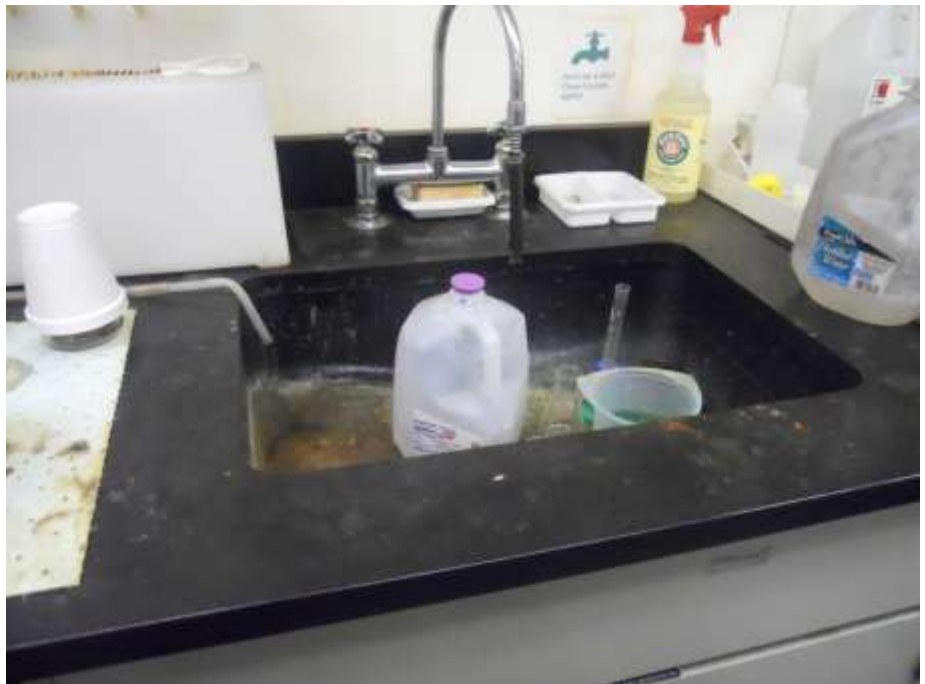
**Disk Number** 1  
**Photo Number** 30  
**Photo Filename** DSCN0615.JPG  
**Date/Time** 9/11/2013  
10:55:00 AM  
**Photographer** Jamie Paulin

Laboratory. Mid-City Plating stated that the material that is put down the sink travels to the WWT unit for treatment.

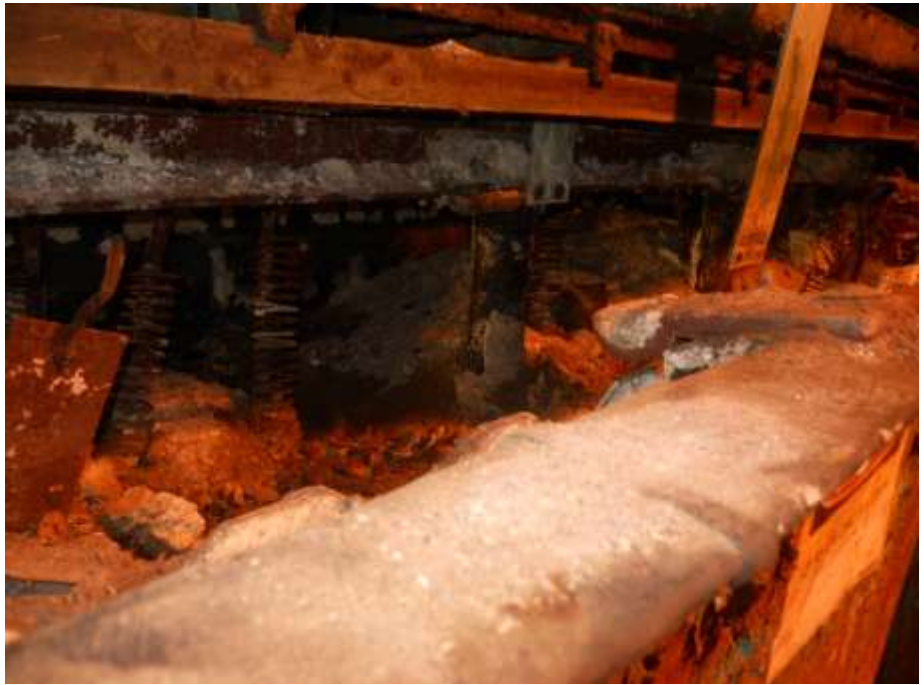
**Disk Number** 1  
**Photo Number** 31  
**Photo Filename** DSCN0616.JPG  
**Date/Time** 9/11/2013  
10:57:00 AM  
**Photographer** Jamie Paulin

Utilite Machine. Material and debris were still located inside of the machine, which was not in-use at the time of the inspection.

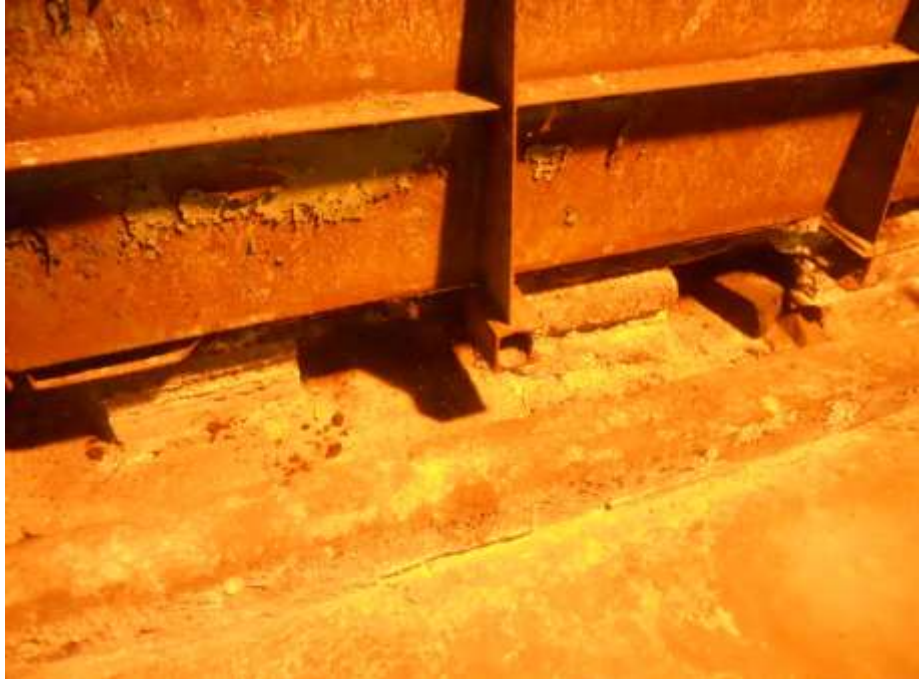
**Disk Number** 1  
**Photo Number** 32  
**Photo Filename** DSCN0617.JPG  
**Date/Time** 9/11/2013  
10:58:00 AM  
**Photographer** Jamie Paulin

Utilite Machine. Material and debris were still located below the machine, which was not in-use at the time of the inspection.
